**Flood Control Project Maintenance  
Levee Inspections  
LMA District Cover Sheet  
Spring 2012 Levee Inspection Results**

**Sutter Maintenance Yard Maintenance Area 0007**

**Levee Inspection Report By Mile - Spring 2012**

Waterway		Bank	Unit Miles	Inspection Start/End	Inspector
Unit No. 01 Feather River		Right	12.07	03/28/2012 03/28/2012	Clay Thomas

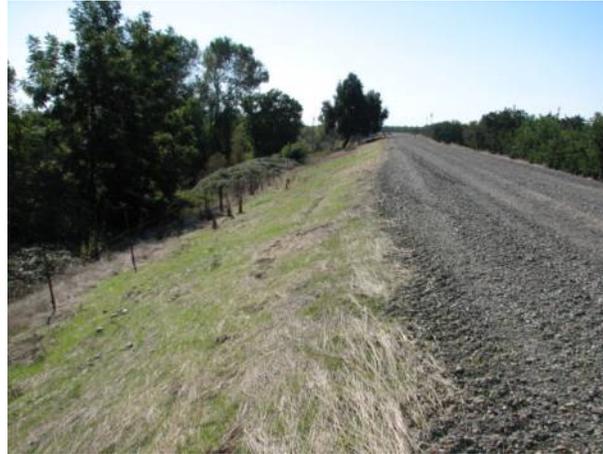
Levee Mile Report Line	4
Start Levee Mile	0.01
End Levee Mile	11.90
Location	Water Side
Category	Earthen Levee
Item	Vegetation

This photo shows the waterside vegetation at levee mile 11.61 looking downstream.

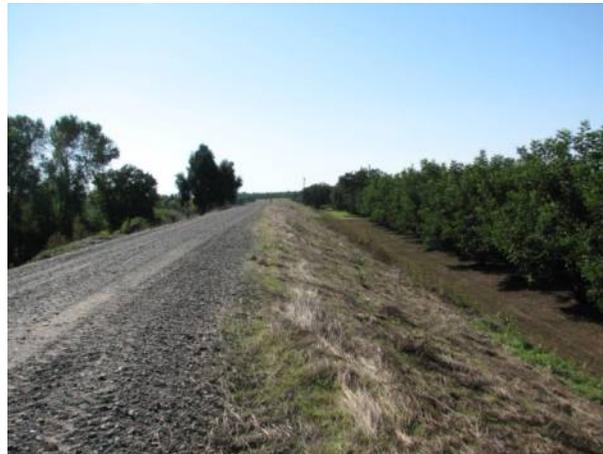
Levee Mile Report Line	5
Start Levee Mile	0.01
End Levee Mile	11.90
Location	Land Side
Category	Earthen Levee
Item	Vegetation

This photo shows the landside vegetation at levee mile 11.61 looking downstream.

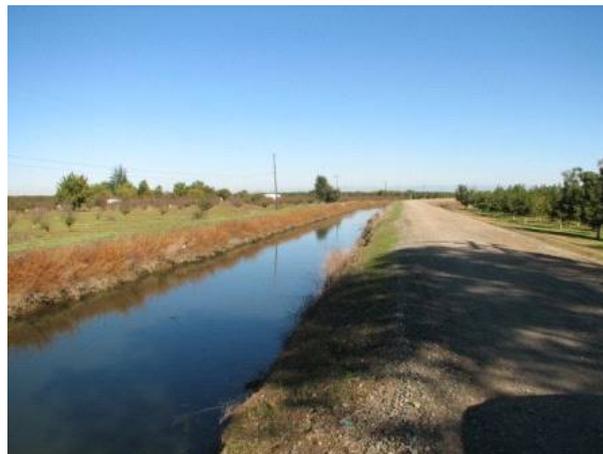
Levee Mile Report Line	6
Start Levee Mile	0.01
End Levee Mile	1.73
Location	Land Side
Category	Earthen Levee
Item	Encroachments

AG ditch landside slope and toe.

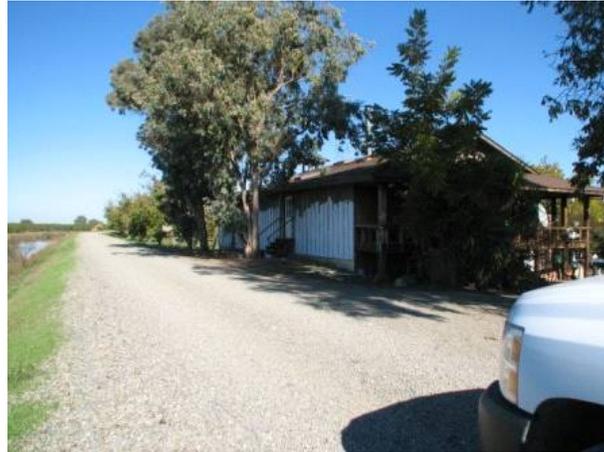
Levee Mile Report Line	7
Start Levee Mile	1.21
End Levee Mile	1.21
Location	Water Side
Category	Earthen Levee
Item	Encroachments

Levee mile 1.21. This is a photo of the building on the waterside slope.

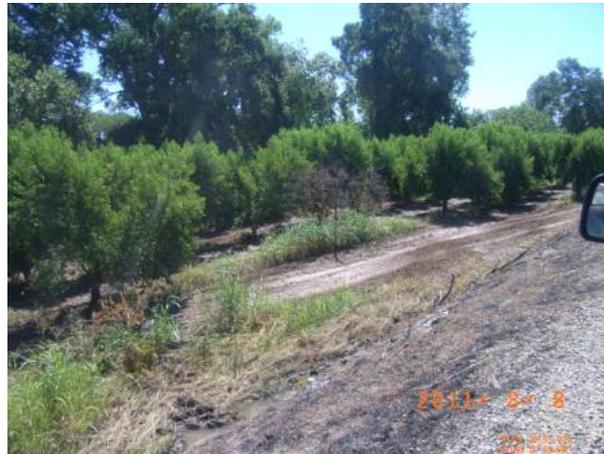
Levee Mile Report Line	8
Start Levee Mile	1.51
End Levee Mile	1.51
Location	Water Side
Category	Supplemental
Item	USACE Erosion Survey

USACE 2011 Photo #1

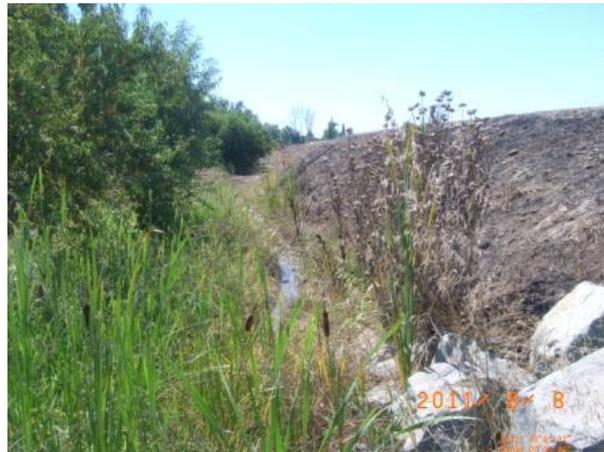
Levee Mile Report Line	8
Start Levee Mile	1.51
End Levee Mile	1.51
Location	Water Side
Category	Supplemental
Item	USACE Erosion Survey

USACE 2011 Photo #2

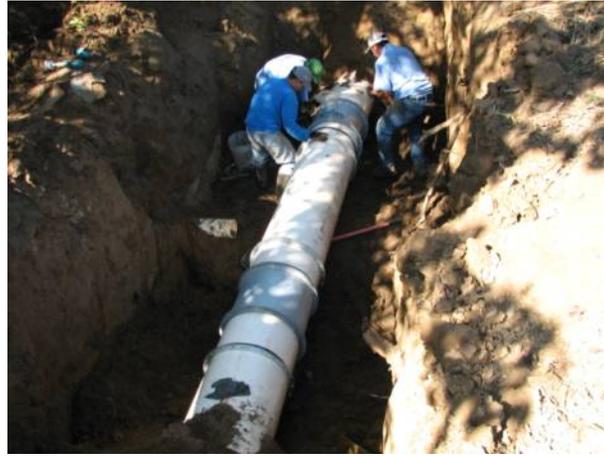
Levee Mile Report Line	10
Start Levee Mile	2.88
End Levee Mile	2.88
Location	Land Side
Category	Earthen Levee
Item	Encroachments

This photo shows a pipe approximately 24 inch in diameter at the landside toe of the levee, the pipe runs parallel with the levee, they are repairing the existing pipe.

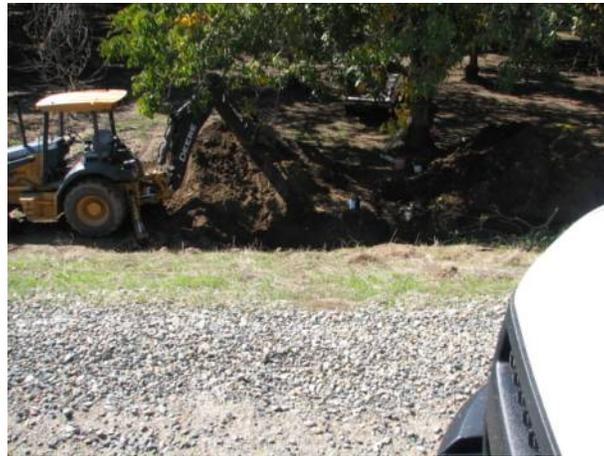
Levee Mile Report Line	10
Start Levee Mile	2.88
End Levee Mile	2.88
Location	Land Side
Category	Earthen Levee
Item	Encroachments

This is looking from the crown of the levee at the pipe repair site. Status of a permit is unknown and no verification of the repair was available.

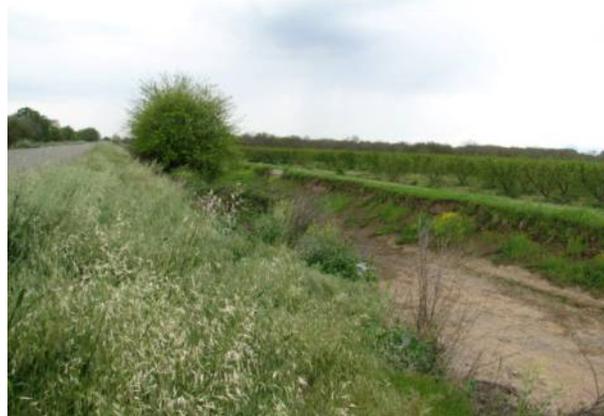
Levee Mile Report Line	12
Start Levee Mile	3.85
End Levee Mile	5.37
Location	Land Side
Category	Earthen Levee
Item	Encroachments

Levee mile 5.37. This is a photo of the Ag ditch on the landside slope and toe.

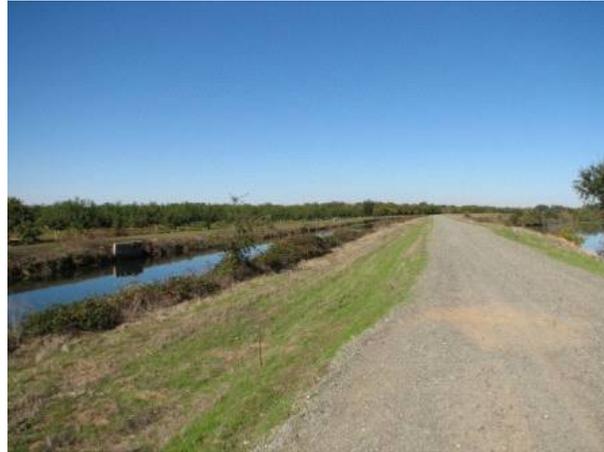
Levee Mile Report Line	12
Start Levee Mile	3.85
End Levee Mile	5.37
Location	Land Side
Category	Earthen Levee
Item	Encroachments
Ag ditch landside slope and toe.	
cathom_s_20120307_017.jpg

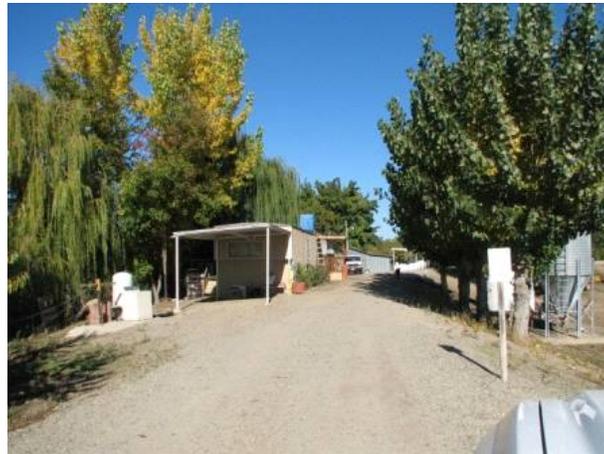
Levee Mile Report Line	16
Start Levee Mile	5.42
End Levee Mile	5.42
Location	Land Side
Category	Earthen Levee
Item	Encroachments
Levee mile 5.42. This photo shows a building on the landside crown, shoulder and slope.	
cathom_s_20120307_014.jpg

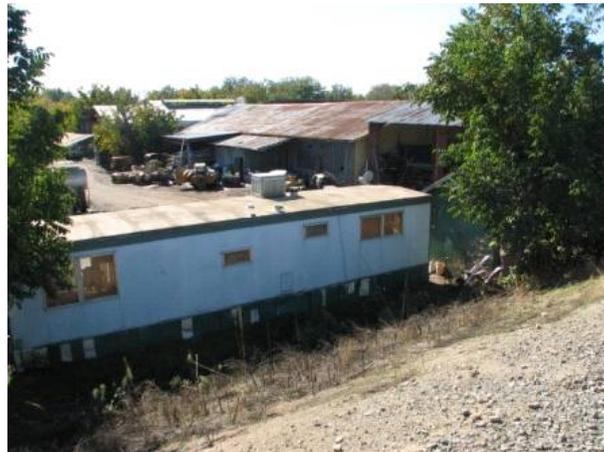
Levee Mile Report Line	23
Start Levee Mile	9.79
End Levee Mile	9.79
Location	Land Side
Category	Earthen Levee
Item	Encroachments
Levee mile 9.79. This photo shows a building at the landside toe.	
cathom_s_20120307_020.jpg

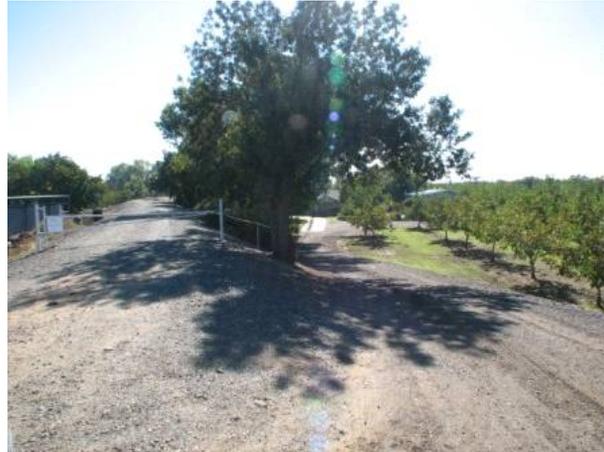
Levee Mile Report Line	27
Start Levee Mile	11.63
End Levee Mile	11.69
Location	Land Side
Category	Earthen Levee
Item	Vegetation
Landside landscaping levee mile 11.63.	
cathom_s_20120307_019.jpg
